UCRL-51749

STUDIES OF RADIATION BLISTERING EFFECTS ON VOLTAGE HOLDING

George H. Miley

March 31, 1975

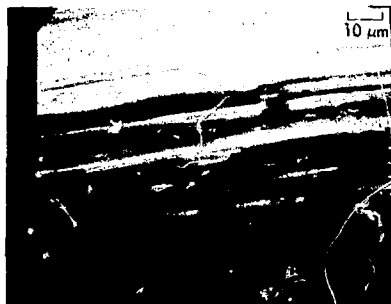
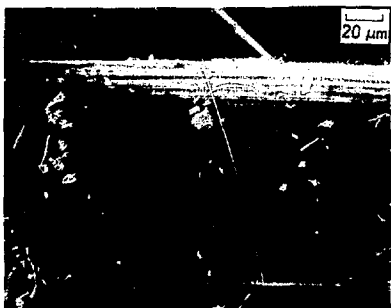
Fig. 6. Enlarged SEM photos of polished niobium wire (electropolish, upper photo; chem-polish, lower photo).

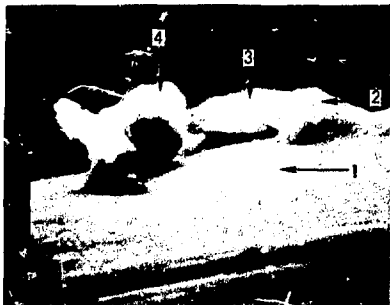
Fig. 7. Some foreign matter remaining after polishing. As seen from the microprobe traces, the protrusions contain a calcium silicate along with phosphates. (KαAl indicates the location of Ka emission from Al, and so on.

it was concluded that this was some debris remaining after the polishing procedure. Such protrusions could play an important role in breakdown, so subsequent wires were given even more extensive washing in CCl_4 and distilled water after polishing. A second point that deserves continued study is heat treatment, used successfully in both the earlier and present studies to condition surfaces. Figure 8 clearly shows a smoothing of the tungsten grooves plus the formation of a

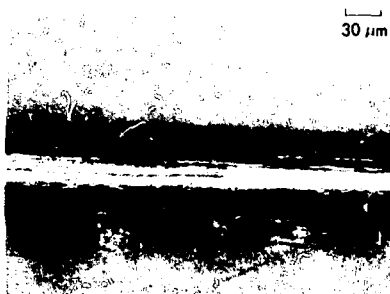
Fig. 8. Optical microscope view of tungsten wire after heat treatment for 2 hours at 1125°C . Smoothing of the groove structure plus grain formation is observed.

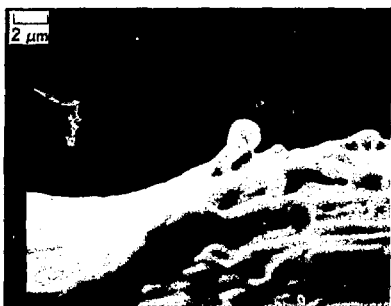
Fig. 16. Massive crater due to breakdown to 2-mil tungsten wire. Lower photo is an enlargement of the projection on right edge of crater.

Several other interesting features are visible in these photographs. In Figs. 16 and 17, a distinctive structure occurs around the edge of the large crater. In Fig. 17, a bent whisker-like formation with a ball on its end is clearly visible. The microprobe analysis of the ball confirms the presence of aluminum, indicating that this structure played a part in prebreakdown emission and/or the arc. (No aluminum was found on the wires before voltage tests. Thus, as noted earlier, any aluminum must have been transported from the projection-tube liner.) The exact size of the bent structure is hard to determine due to the angle of the photograph. Its diameter appears to be about $8000\ \text{\AA}$ and the height could easily be 5 to 10 times this. This falls close to the upper limit of whisker sizes estimated earlier.

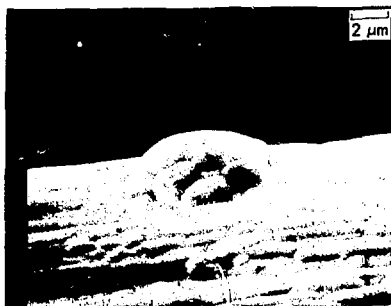
Fig. 18. Bump-like structure on 2-mil tungsten after breakdown, thought to be base of evaporated whisker.

Another structure found near an emission site is shown in Fig. 18. While there is no direct evidence that this bump-like formation was involved in arcing, it could conceivably be the base of a vaporized whisker.

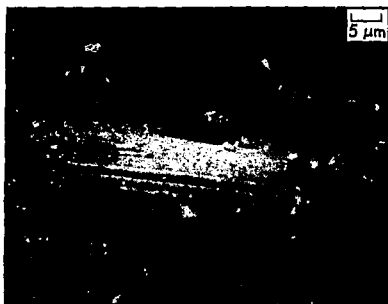
Fig. 24. Scan of blistered and arc region on 3.2-mil niobium (upper photo). Structure in lower photo was found to contain aluminum.

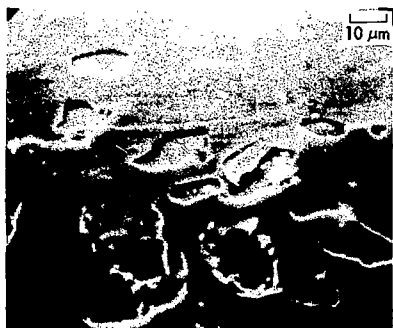
Fig. 27. Flaking on surface of a reference wire irradiated simultaneously with the 4.2-mil niobium wire. Both wires were chemically polished before irradiation. Postmortem photos of the wire tested for breakdown were not made, since it broke during insertion into the SEM.
